OPERATING EXPERIENCE WEEKLY SUMMARY

Office of Nuclear and Facility Safety

October 9 - October 15, 1998

Summary 98-41

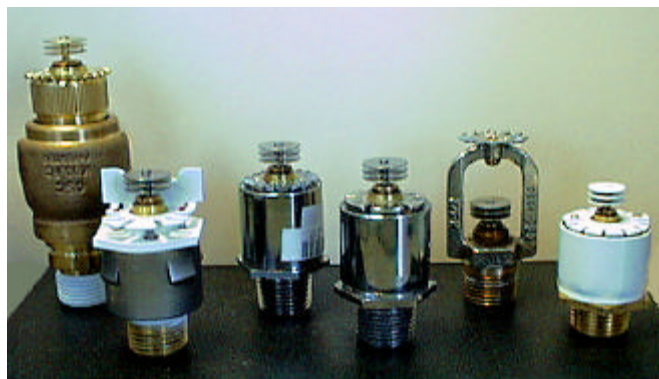
Figure 1-1. Omega Sprinklers

On October 14, 1998, the U.S. Consumer Product Safety Commission (CPSC) officially recalled the Omega brand fire sprinklers that have been manufactured since 1982 by Central Sprinkler Corporation and a subsidiary, Central Sprinkler Company. The CPSC staff believes that these sprinklers are defective and are likely to fail in a fire situation. The sprinklers may not properly activate in the event of a fire, thus exposing the public to bodily injury or death. Central Sprinkler will replace the Omega sprinklers at no cost with glass bulb fire sprinklers and will reimburse consumers for some costs associated with removing and replacing the sprinklers. CPSC is aware of 17 fires in which Omega fire sprinklers reportedly failed to operate, resulting in at least four injuries and over \$4.3 million in property damage. (Press Release 99-008)

CPSC has issued a recall for Omega sprinkler models marked as C1 (or C-1), C1A (or C-1A), C-1A PRO (or C1-A PRO), C1-A PRO QR, EC-20, EC-20A, R-1, R-1A, R-1M, Flow Control (FC, Flow Control-FC), Protector-M or M Protector (Upright, Pendent, Sidewall, Sidewall EC), HEC-12, EC-12 RES, HEC-12 EC, HEC-12 EC PRO, HEC-12 ID, HEC-12 PRO, HEC-12 PRO QR, HEC-20, Prohibitor QR, and AC. Figure 1-1 depicts some of these Omega models.

OEAF engineers reported Omega sprinkler deficiencies in Weekly Summaries 98-12 and 97-49. These Weekly Summaries discussed an event in which an engineer at the Hanford Site Plutonium Finishing Plant notified a building emergency director that three of seven Omega flow control sprinklers removed from the facility failed during testing. The manufacturer, Central Sprinkler Corporation, notified customers of a potential defect with its Omega series sprinklers and asked them to submit samples for testing. Central Sprinkler Corporation determined that the Omega sprinklers failed to activate at low pressures because of reactions between an internal O-ring and residual hydrocarbons in the sprinkler system water from cutting oils or from improper use of stop-leak products. In June 1996, Central Sprinkler changed the O-ring material from ethylene propylene diene monomer to silicone, eliminating the hydrocarbon reaction problem. (ORPS Report RL--PHMC-PFP-1997-0050)

Central Sprinkler established the Omega Sprinkler Recall Hotline, (800) 896-5685, and a website at <http://www.omegarecall.com> for consumers to obtain replacements and reimbursements. Consumers must submit a claim and release to Central Sprinkler, postmarked by August 1, 1999, to obtain reimbursement for any installation costs. Additional information about the CPSC recall can be obtained by calling the Commission at (800) 638-2772 or accessing its website at <http://www.cpsc.gov/cpscpub/prerel/prhtml99/99008.html>. The CPSC website includes a video news release to help consumers identify the sprinklers.
